Test Certificate

No. 201001E-007

Produkt: **Stability Evidence Test, Partition Wall System 1500**
Hinged Door with 45 mm Frame

Stability testing of a light interior partition wall (width 5,00 m, height 2,75 m).

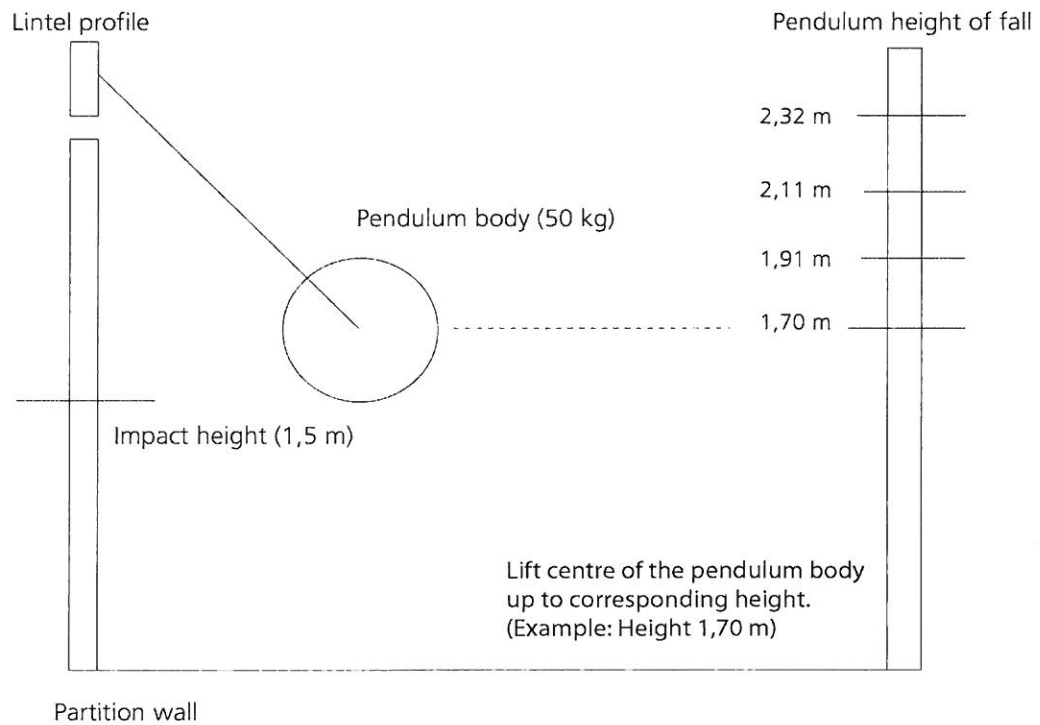
The pendulum hit the wall at two points (see drawing) with the following results:

Post between fix element 3 and 4

Corner profile between hinged door and fix element 3

Category I	requirement of structural damage and functional failure	satisfied
Category II	requirement of structural damage and functional failure	satisfied
Category III	requirement of structural damage and functional failure	satisfied
